Preliminary Arborist Report

**Senior Housing
Contra Costa County, CA**

**PREPARED BY:
HortScience | Bartlett Consulting
325 Ray St.
Pleasanton, CA 94566**

July 2020

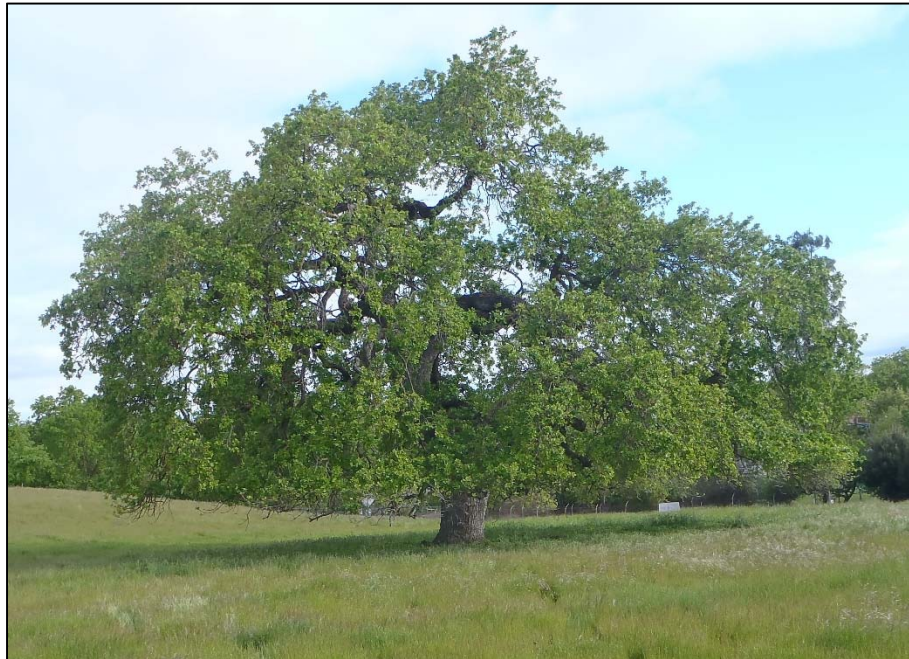
Photo 1: Looking northeast at valley oak #428, one of a handful of valley oaks with trunk diameters above 36" on the site. Valley oak #428 measured 50" in diameter and was in good condition, with a spreading crown.

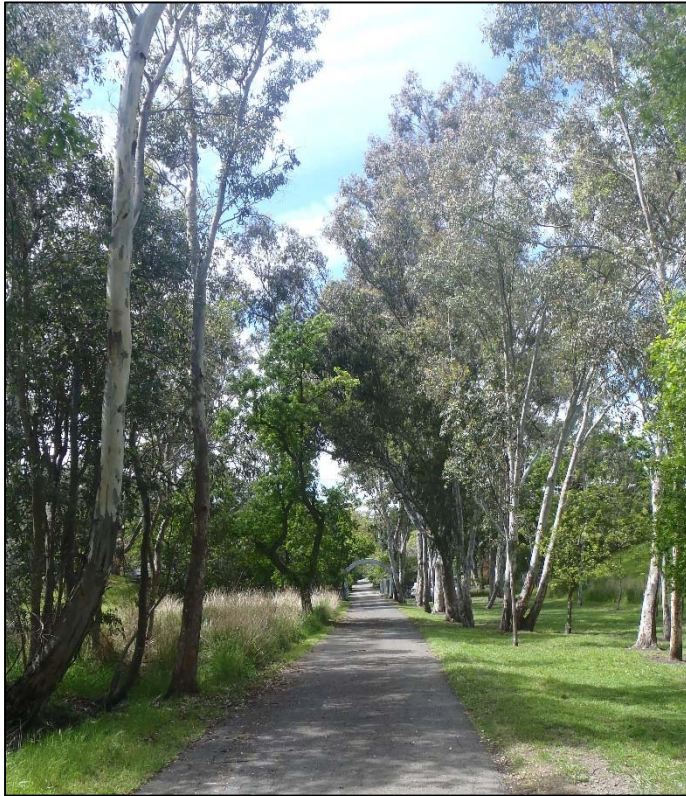
Most of the 89 river red gums lined the entry to the property (Photo 2, following page), with the remaining ~30 growing around the residence and outbuildings. Generally, those along the entry were young to semi-mature, with an average trunk diameter of 14", and those around the residence were mature with an average trunk diameter of 22". River red gum had not performed as well as the native oaks and 15 were in good condition, 48 were in fair and 26 were in poor.

Photo 2 (L): Looking west along the entry drive onto the property from Seven Hills Ranch Road. The entry was lined with ~60 young to semi-mature river red gums and ~20 young to semi-mature valley oaks.
